Project Profile

Inspection of Slurry Pipe

| Application Type | Pipe Internal Corrosion / Erosion |
| Client | Withheld (Aluminium Industry) |

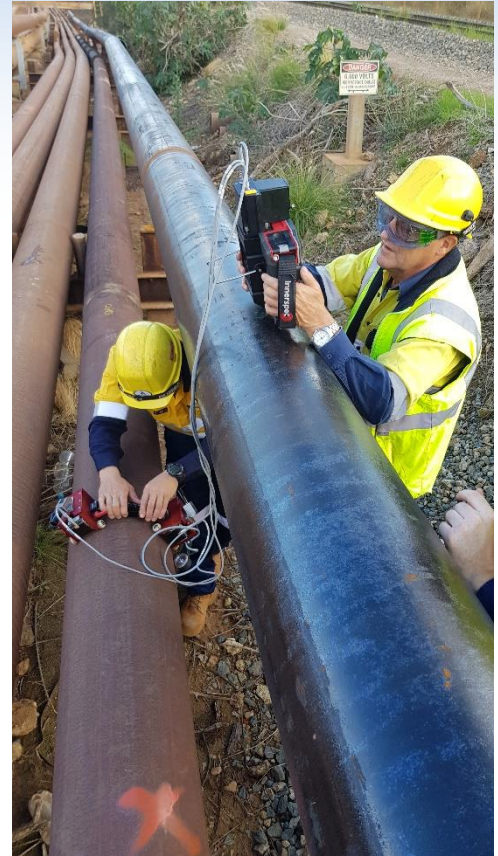
The solution in this case was to use the Innerspec MRUT-A equipment to do a full-length, full circumference, full wall thickness scan of the pipe.

The scan was conducted in a matter of weeks, and detected a number of areas to be monitored, and at least one area where the above mentioned defect had reached a point where it requires repair. These areas would not have been detected using other methods with the same timeframe and budget.

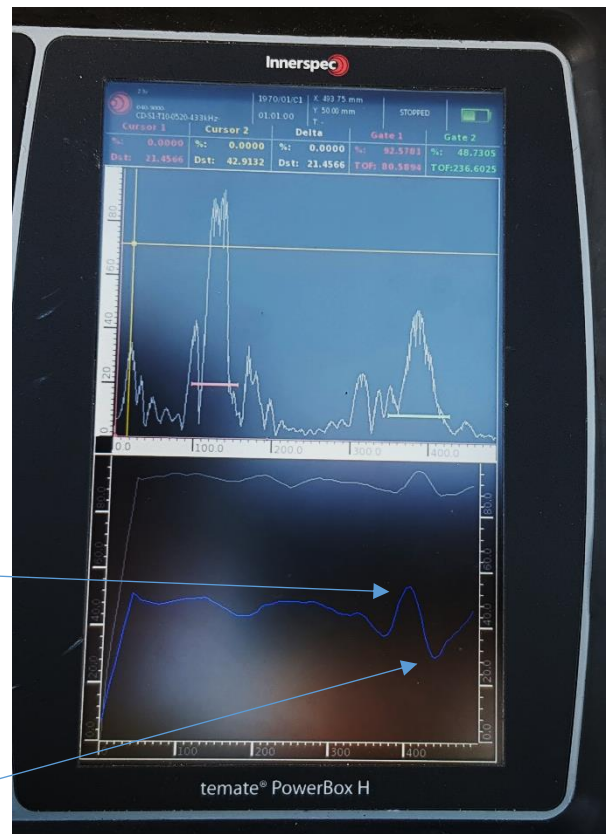
The image to the bottom right shows a typical screen-shot of what the strip-curve looks like at the location of this type of defect. This is indicative of the beginning of a defect rather than a significant wall loss.

Increase in thickness under the scale before the defect

Defect: Decrease in thickness after the scale.
